MIXED-USE ROW BUILDINGS

A Publication of The New Haven Preservation Trust

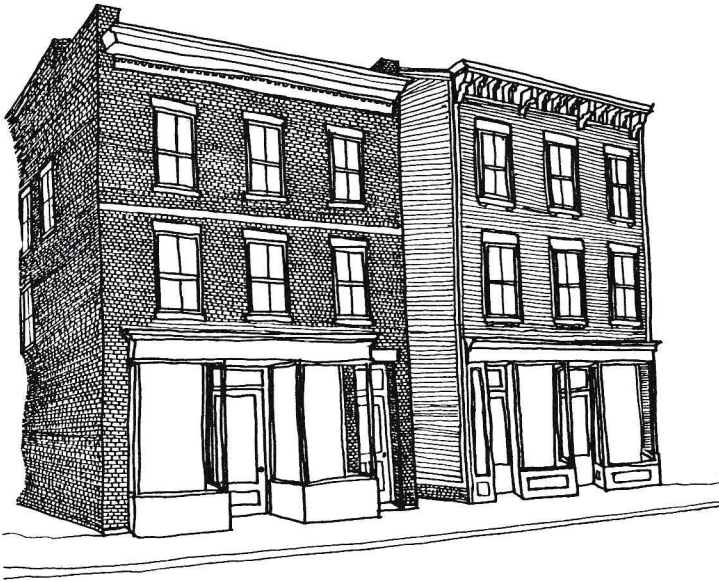
ITALIANATE STYLE

(1) Italianate style: 1860 to 1890 - Typical exterior features shared by brick, frame, and cut-stone buildings include prominent main cornices projecting outward over tall frieze panels embellished by scroll-sawn brackets and decorative moldings, and 2-over-2 pane double-hung windows. Typical features shared by brick and cut-stone buildings include cut-stone window and door sills and lintels and decorative bands of cut-stone trim spanning portions of walls. Typical features shared by frame buildings include clapboard siding and bracketed, projecting window trim.

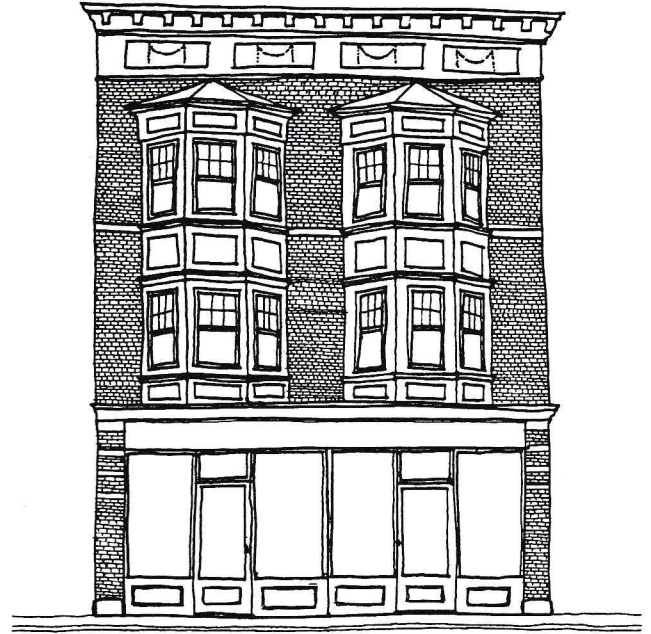
COLONIAL REVIVAL STYLE

(3) Colonial Revival style: 1895 to 1925 - Typical features shared by brick, frame and cut-stone buildings include simply detailed main cornices projecting slightly outward over tall main frieze and architrave panels embellished by classically derived motifs (such as denticulated moldings, modillion brackets, or swag), column-like pilasters rising along the corners of the buildings, projecting front upper-story window bays, and 1-over-1 or 6-over-1 pane double-hung windows. Typical features shared by brick and cut-stone buildings include cut-stone window and door sills and lintels, arched window or door openings, and decorative bands of cut-stone trim embellishing portions of walls or storefront end piers. Typical features shared by frame buildings include clapboard siding and decorative window trim.

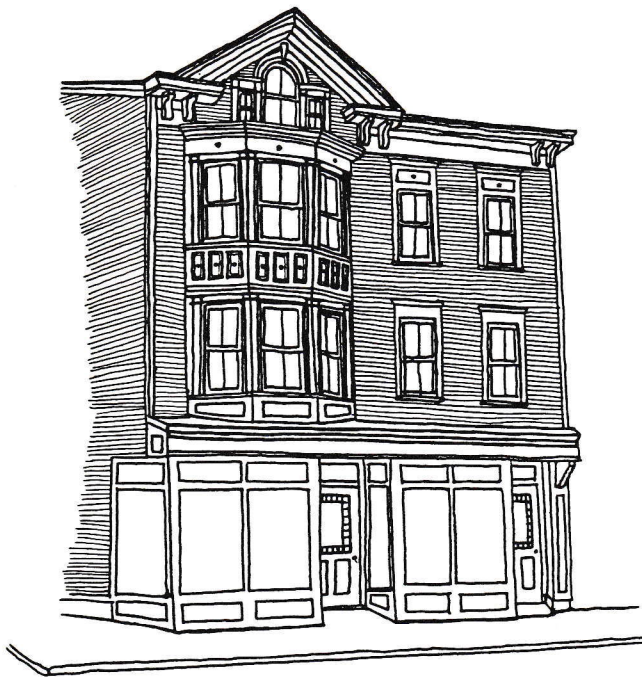
QUEEN ANNE STYLE

(2) Queen Anne style: 1885 to 1910 - Typical exterior features shared by brick, frame, and cut-stone buildings include prominent main cornices extending outward over tall frieze panels embellished by scroll-sawn brackets and decorative moldings, 2-over-2 or 1-over-1 pane double-hung windows and/or decorative double-hung windows with upper sash featuring panes of differing size and color patterns, large projecting front gable dormers, and projecting, front upper-story window bays. Typical features shared by brick and cut-stone buildings include cut-stone window and door sills, arched window openings of decoratively detailed cut-stone or brick, and decorative bands of brick, cut-stone or terracotta spanning portions of walls. Typical features shared by frame buildings include clapboard and/or wood-shingle sidings.

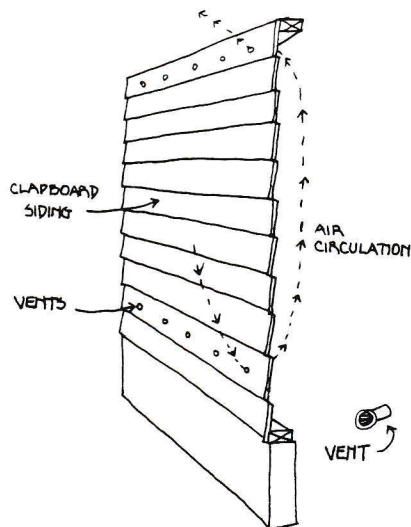
VENTING EXTERIOR WALLS

On wall surfaces, blistering and peeling often result from either a buildup of excessive moisture within the wall cavity behind the paint or from using an incompatible paint type. For example, if oil paint is applied over latex, peeling of the top coat can sometimes result. Some possible remedies which may help to alleviate moisture problems include: repairing leaky roofs; repairing and sealing walls and floors in damp basements to reduce or eliminate moisture penetration into wall cavities from this source; painting or wallpapering interior sides of the affected walls with products designed to act as vapor barriers; and, in extreme cases, installing a system of louvered wall plugs designed to vent exterior wall cavities through natural convection. Once the problem has been remedied, the affected area should be thoroughly cleaned, scraped and/or sanded; painted with a high-quality oil-based primer; and repainted with latex or oil paint according to the manufacturer's specifications.

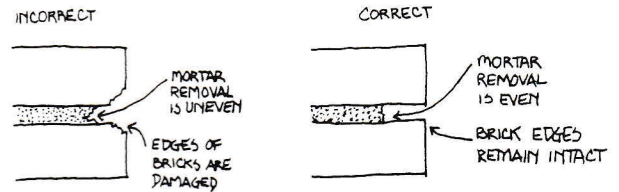
REPOINTING: REMOVING OLD MORTAR

Deteriorated mortar should be repointed. Loose mortar should be removed from the affected area by hand with a hammer and chisel to a uniform depth of 1/2-1". To ensure a good bond, flush chiseled joints with water prior to refilling them with new mortar. **Important Precautions:** When removing old mortar, do not chip the edges of the surrounding bricks. This will accelerate the deterioration of the brick. Make sure that new mortar matches the color and composition of the original mortar. Most older buildings have bricks designed for use with soft lime mortar; hard cement-based mortars can eventually damage the surrounding bricks. If you are unsure of the type of mortar to use, have some of the original analyzed at a high school or college chemistry laboratory to determine the proper mix. Finally, never refill a joint completely; finished joints should always be slightly recessed.

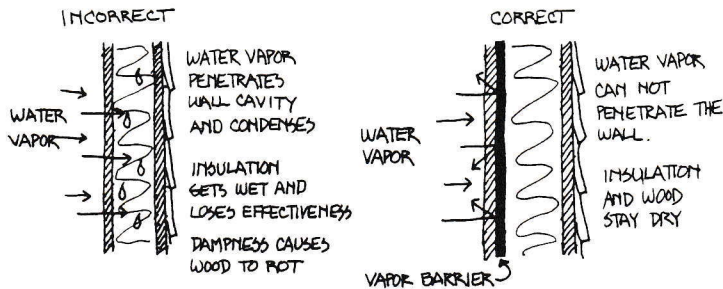
INSULATING SIDE WALLS

A safe and effective way to insulate a side wall with interior wall surfaces that are already in need of replacement is to remove the interior wall surface, install fiberglass batt insulation between the exposed studs, cover it with an appropriate vapor barrier material such as polyfilm, and install a new interior finish surface directly over the vapor barrier. In masonry buildings, interlocking rigid-foam insulating panels applied directly over furring strips attached to the inside faces of outside walls can be used in place of fiberglass batts.

In order to avoid ripping out plaster, many property owners decide to have insulation blown into the wall cavities. Be careful! Blown-in insulation techniques rarely include provisions for effective vapor barriers. Without them, when warm water vapor from the interior comes in contact with cold insulation during the winter, it will condense into water. The result is soggy and ineffective insulation. Since air cannot circulate through the wall, moisture may become trapped and cause masonry deterioration, rot in frame walls, or peeling exterior paint.

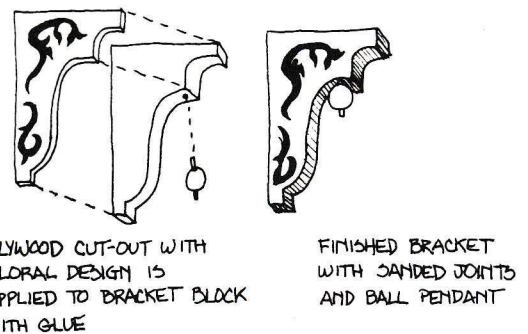
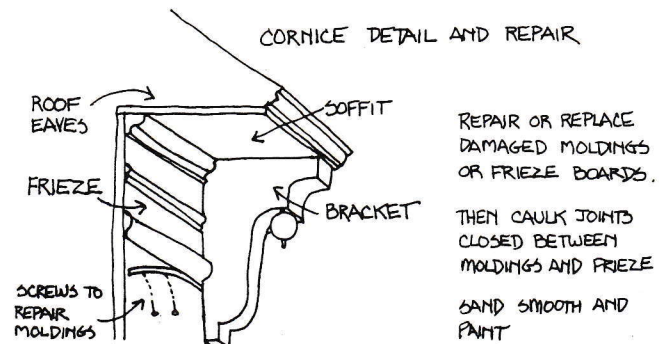
DUPLICATING A BRACKET

Epoxies, polyesters, and synthetic resins available on the market today often allow for repair rather than replacement of partially rotted or broken features such as porch posts and railings. With the use of such materials, rotted sections can often be cut out and refilled; and broken or cracked brackets, balusters, moldings, doors, and other wooden features can often be reglued. Features beyond repair can be reproduced with a jig or sabre saw and drill and stock lumber, using an intact, similar feature as a model. Intricate features such as brackets can often be made in sections and then glued together with waterproof epoxies. If exact reproduction of a feature such as a molding is not possible, approximate the size and shape of the original as closely as you can.

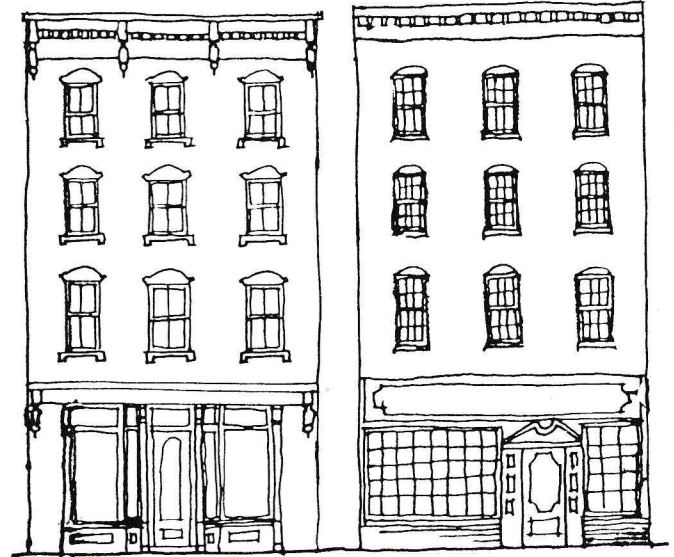
Nineteenth/early twentieth-century mixed-use row building storefronts are characterized by display windows featuring large panes of glass. Often, these large display windows are topped by rectangular transom windows. When repairing storefronts, many well-intentioned owners go too far in attempting to make this feature look "historic." The most common error most owners make is to "Colonialize" the front by installing multiple-pane display window grids. This treatment is not only historically inappropriate; often, it makes the store less desirable to potential tenants seeking large unbroken window areas in which to display their wares. An old photograph of the building showing an intact original or early storefront is usually the best design guide on which to base your repairs. If such a photograph is unavailable, you can use the drawings found on the previous pages as a general guide. You may also find it helpful to contact a local or state historic preservation office for design assistance.

APPROPRIATE

INAPPROPRIATE
